3D Image Clinical Cases

Endodontics

Endodontics Case 1

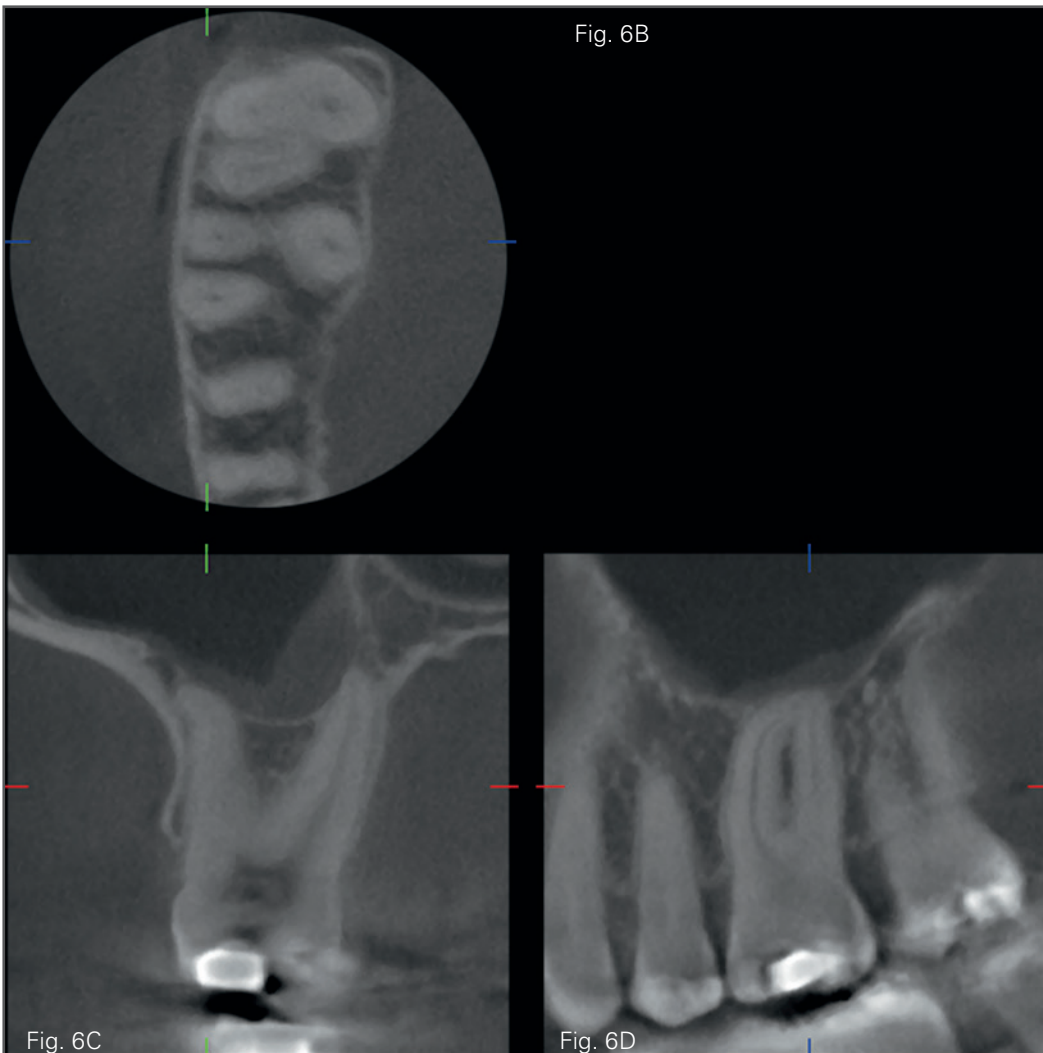
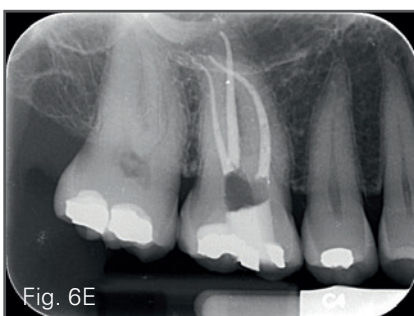
The patient presented with an irreversibly inflamed pulp in tooth # 3, confirmed by cold and heat testing (prolonged responses). Conventional radiographs revealed mesio-buccal root anatomy that was very curved, with the disto-buccal and palatal root anatomy appearing fairly straight (Fig. 6A).

Accutomo CT imaging revealed a different story, allowing me to tread carefully during treatment (Figs. 6B.). The first bit of important information was that this tooth unusually had only three canals (Fig. 6C).

The second piece of very important information was that the curvature of the mesiobuccal canal was truly awe-inspiring (Fig. 6D). The third piece of information saved my self respect and the patient's tooth from a broken rotary file, it revealed a severe canal curvature – in the normally-hidden buccal plane (Fig. 6E). Treatment, as a result was quick and sure with an exceptional (sorry, but it's true) result (Fig. 6E).

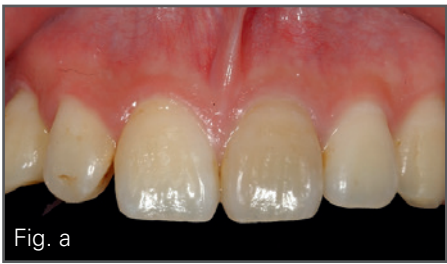
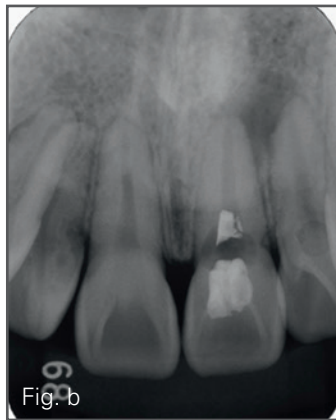
a./b. The first examination. A 20 year old male. The chief complaint was the discoloration of the crown of # 9 and slight pain. External resorption from the palatal aspect and LEO were found. He has an experience of subluxation of the involved tooth 3 years ago.

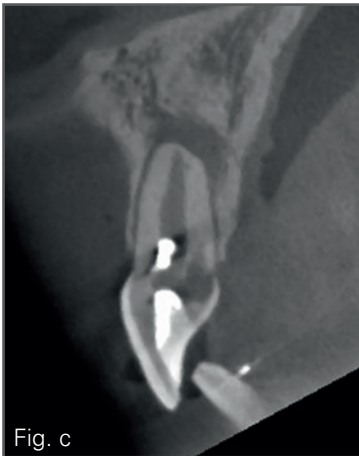
c./d. CBCT appearances. c: sagittal. d: axial. The root resorption start from the cervical area on the palatal aspect and invaded into the dentin.

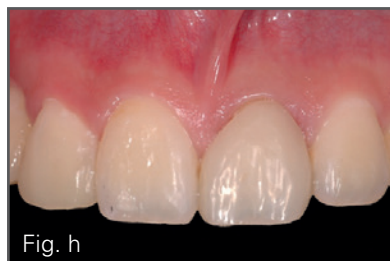
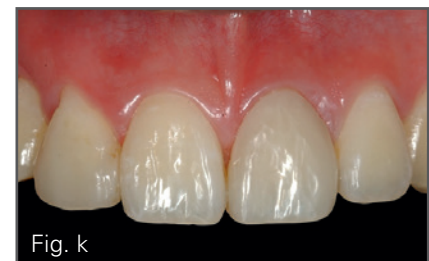
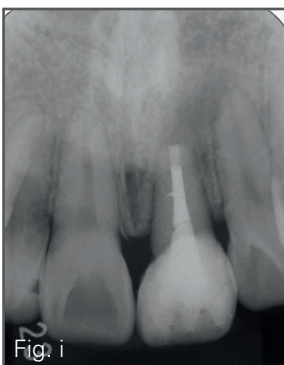
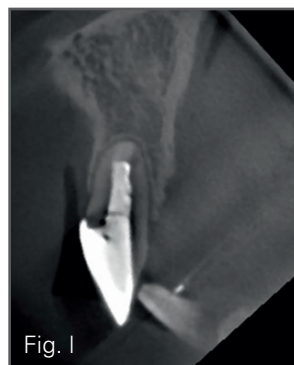
l. CBCT appearance 1 y. post op. The PDL space and the buccal alveolar bone is nicely preserved. No resorption is observed. Interesting is that the PDL is formed over the retro-filling materials.

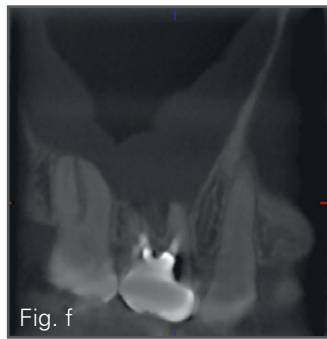
i.-l. CBCT appearance six months later. The sinus bone has come back and the Schneiderian membrane looks normal.

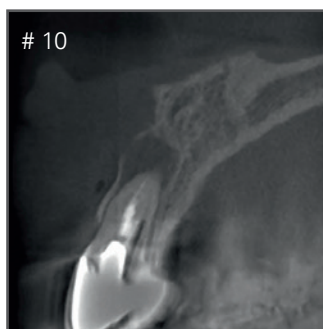
Apicoectomy and follow-up with CBCT.

A 41 year old female. # 9 and # 10 suffer LEO and apicoectomy was indicated.

3 mm of each apex was cut off and the bony defect was filled with Bio-oss after the retro-fillings. The healing of the involved teeth was followed up with CBCT.

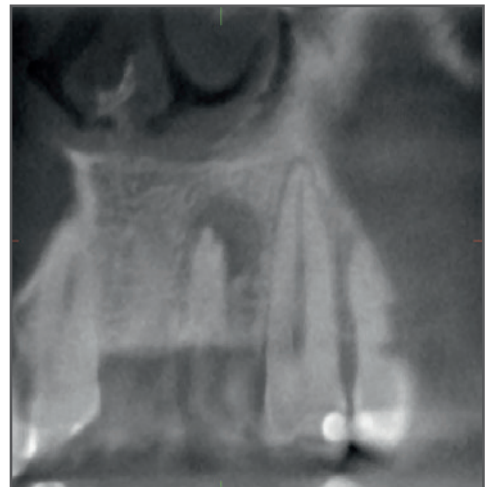
The periapical and panoramic radiographs show an "acceptable" endodontic treatment reaching the slightly lateral apex of tooth # 10. The endodontic filling lateral appears to be "doubled", giving the impression of the presence of two canals. Ill-defined periapical radiolucency is noted slightly on the distal aspect of the apical third.

Cone beam images show that the gutta percha is perforating the facial aspect of the root and the buccal cortex. Some gutta percha is found in the canal but it is not reaching the apex.

Periapical radiograph is a 2D presentation of a 3D object; it collapses all the structures in the examined area in one plane. The image of the gutta percha is projected over the image of the root giving the impression of an acceptable treatment.

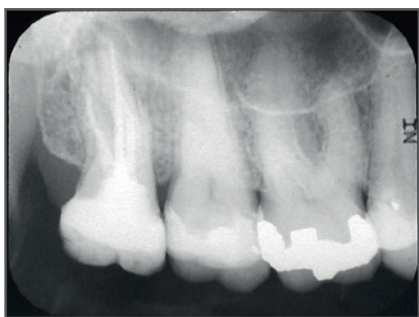
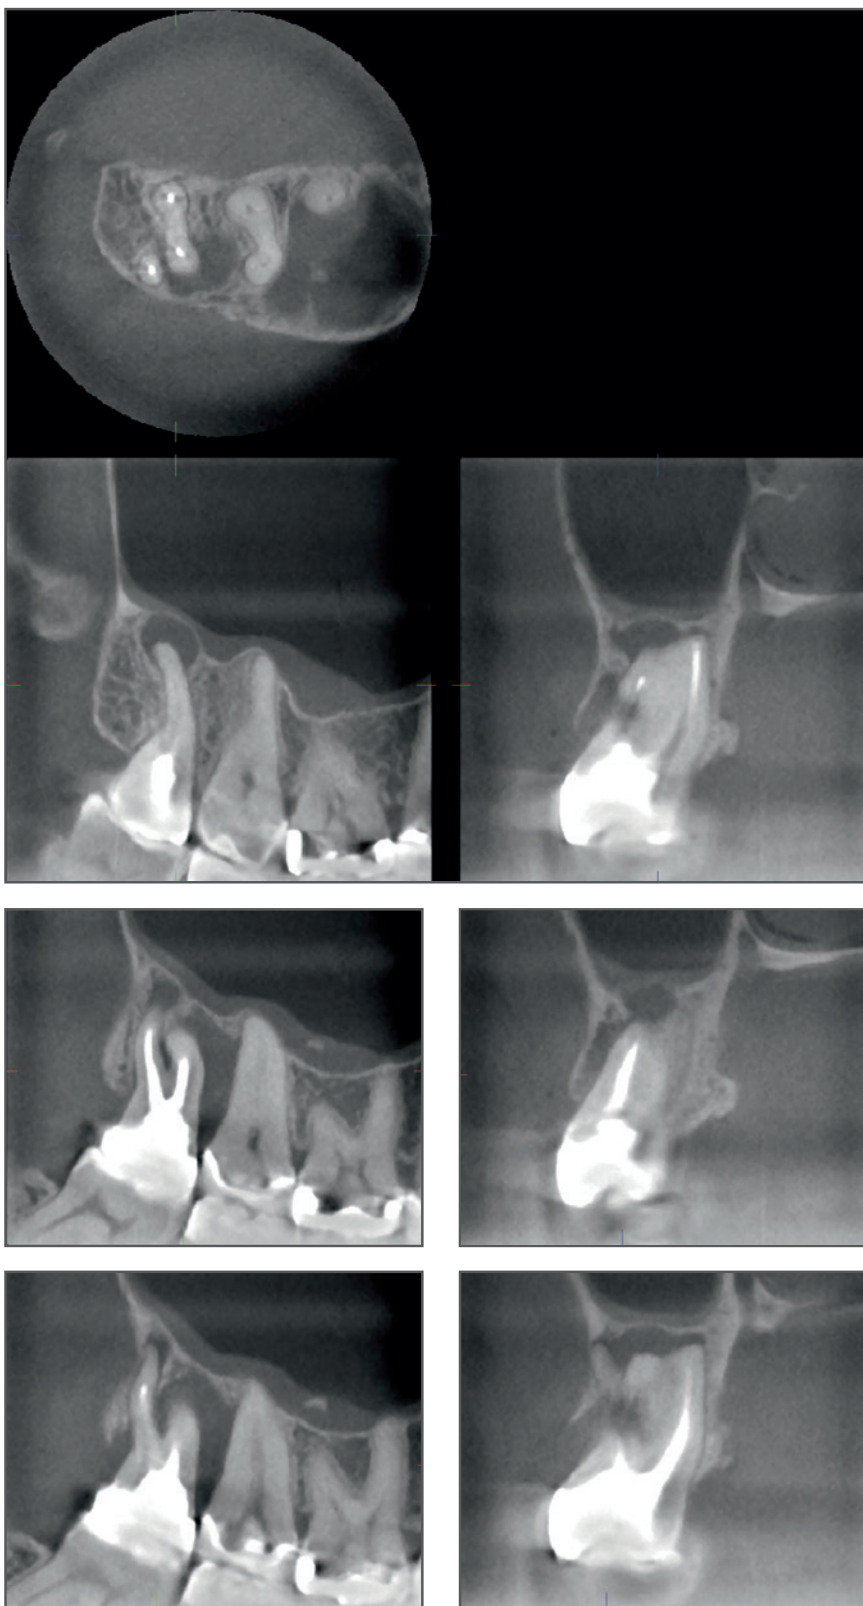
The periapical radiograph shows a well corticated, 3–4 mm periapical radiolucency onto the second molar. The tooth is endodontically treated and the endodontic filling material is homogenous, well condensed, and reaching the apex.

On the cone beam CT, the periapical lesion presence is confirmed with the presence of a severe vertical periodontal bone loss reaching the apex of the tooth in the form of what we call “endo-perio” communication. This finding was not seen on the periapical film due to the projection of the buccal and palatal thick cortical bones over the image of the periodontal lesion.

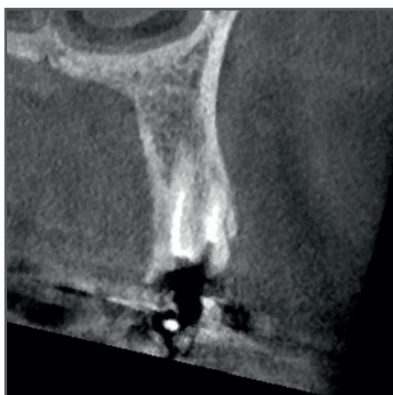
The patient was complaining of diffuse pain over the left maxilla. Conventional radiographs did not reveal pathological changes in the periapical region of premolars and molars. A Veraviewepocs 3D image shows an air-filled, healthy, maxillary sinus and a periapical lesion at the apex of the buccal root of the first premolar.

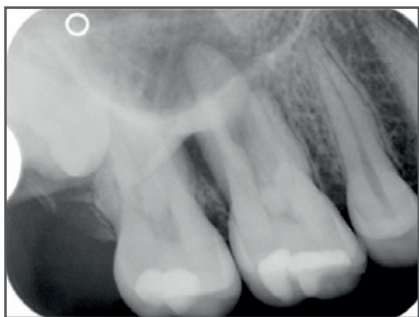
An endodontist had taken several images of the upper right molar region on a patient who presented with pain. He could see that a lesion was present at the first molar, but was uncertain about its extent.

The Accuitomo images showed a lesion with a very large extent in all directions. It has caused a break-down of both the buccal and palatal cortical borders. It extends into the lateral part of the nasal cavity and the lower part of the maxillary sinus where a reaction is seen in the mucosa. The lesion also involves the root system of the second molar and gets very close to the unerupted third molar. None of this could be anticipated from intraoral radiographs alone.

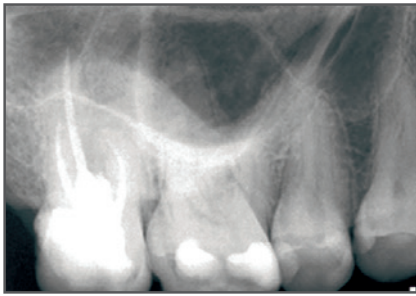
Although having taken several intraoral radiographs, an endodontist still felt uncertain about the conditions at the upper right second molar from which the patient still felt some pain after an endodontic treatment had been completed.

The Accuitomo images show lesions at the two buccal roots and at a palatal root, but also that a second palatal root exists in which the root canal has not been treated. In addition, a lesion is seen in the interradicular area between the latter and the mesiobuccal root. The lesion at the buccal roots extends into the lower part of the maxillary sinus in which a thickening of the mucosa can be seen.

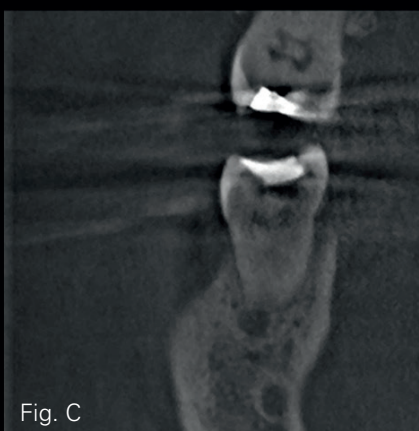
Clinical examination of the LR5, LR6 and LR7, revealed no abnormalities with no tenderness to palpation at the buccal and lingual root apices and no tenderness to percussion of any of the teeth. Vitality testing could not be carried out at the LR6 as the crown margin was subgingival. The LR7 predictably did not respond to the electric pulp test. The periapical radiograph (Fig. A) revealed widening at the periapex of the LR7 with no other signs of pathology.

The sagittal slices of the microCT scan (Fig. B) however clearly showed a 4 mm circular lesion associated with the apex of the distal root of the LR7. The reason why this could not be seen on the periapical radiograph could be understood from the coronal slice (Fig. C) that shows the lesion positioned entirely in cancellous bone and not involving the cortical plates – the prerequisite for visibility on a standard periapical radiograph. Furthermore the anatomy of the root canals in the LR7 could be visualized with there being clearly one mesial and one distal canal (Fig. D).

Without the microCT scan provided by the Veraviewepocs 3D, an attempt would have been made to find another canal in the LR7, as there was no reason to treat the LR6. Significant damage to the root of the tooth would have occurred before the search would have been abandoned, and the patient would still have been in pain following the procedure. With the scan, treatment was initiated immediately in the LR6 and the pain quickly eased. Endodontic treatment of the LR7 when completed, was done without further damage in an attempt to locate a second mesial canal (Fig. E).

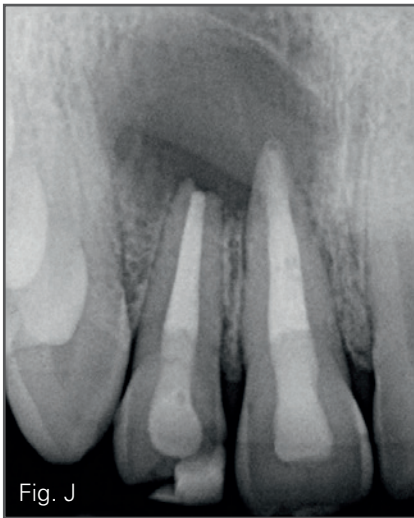
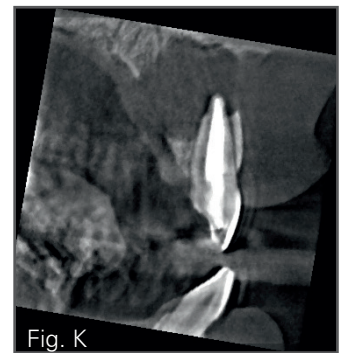
A 24 year old male patient attended 2 years following root canal therapy of his upper right central and lateral incisors (UR1 and UR2) with a draining buccal fistula (Fig. J). The teeth had been originally traumatised aged 10 and the apices were incompletely formed. On presentation with periapical infection aged 22 (Fig. F), the orthograde root canal treatments that were carried out had initially involved calcium hydroxide therapy followed by obturation with MTA apical plugs (Figs. G & H). Initial follow up at 6 months suggested some resolution (Fig. I), but the appearance of a fistula 18 months later confirmed regression and reinfection.

A microCT scan of the lesion using the Veraviewepocs 3D (Figs. K & L) revealed the true size of the lesion with both buccal and palatal plate perforations. The usual treatment of a recurrent periapical lesion with a satisfactory orthograde root filling would be buccal approaching periapical surgery with lesion curettage, apicectomy and possibly an apical retrograde seal. However, if this would have been carried out with such a lesion, soft tissue ingrowth from the palatal side would resist bony repair. True repair of a lesion of this size would require either a membrane on one side if the lesion to resist soft tissue ingrowth, or decompression followed by conventional surgery. Whichever is chosen, neither would have been immediately considered in a case such as this, and therefore, poor bone healing would have followed on from a standard surgical approach without the benefit of the microCT scan.

In this case a decompression procedure was carried out and a plastic drain was placed buccally (Fig. M & N) with the patient instructed to irrigate the underlying bony cavity with Corsodyl using a syringe. The drain stayed in place for 2 weeks and was then removed (Fig. O).

A microCT scan carried out after 6 months showed shrinkage of the lesion and full reformation of both buccal and palatal plates (Figs. P & Q). Although buccal approaching periapical surgery with lesion curettage and apicectomy was now possible, with the lesion asymptomatic and good healing it was decided to leave and observe further on the basis that marsupialisation of a true cyst might have occurred and contamination at the root apices were no longer an issue. A further review was scheduled for 1 year.

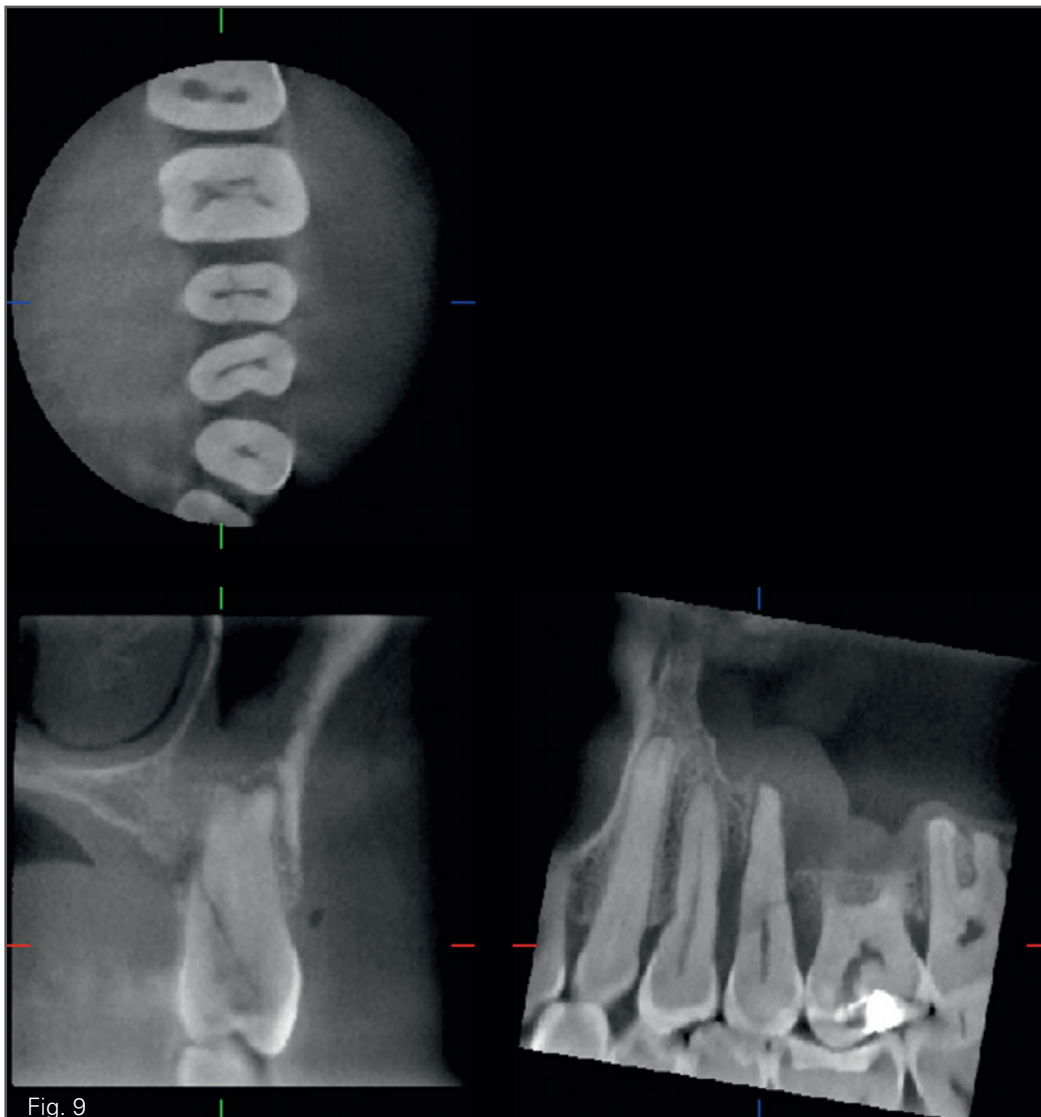
This 48 year old male patient complains of severe pain in the left maxilla that developed after eating. Panoramic (Fig. 8A) and periapical radiographs (Fig. 8B) show a possible widening of the periodontal ligament space at the mesial surface of tooth # 13. The Accuitomo scan (Fig. 9) clearly reveals an oblique fracture of the root of # 13 that extends from the palatal surface of the root towards the buccal surface of the crown of # 13. Interestingly, the fracture does not extend into the enamel, but appears to end at the area of the dento-enamel junction. There is also widening of the periodontal ligament

space along the fracture line. Finally, there is thickening of the mucoperiosteal lining of the floor of the left maxillary sinus consistent with maxillary sinusitis, that most probably is unrelated to the dental disease described above.

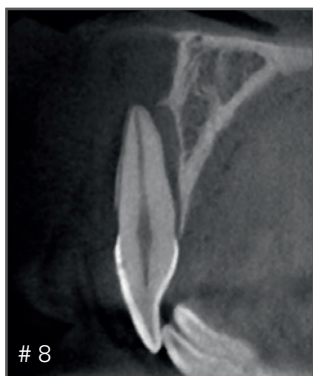
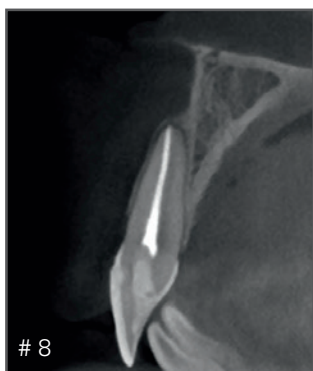
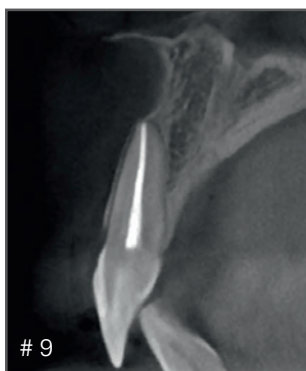
Lateral luxation and follow-up with CBCT.

A 23 year old female. Two central incisors are involved with lateral luxation, which is very difficult to diagnose with conventional methods, but is easily revealed with CBCT.

One year 3 months follow-up result with CBCT has shown the complete healing.

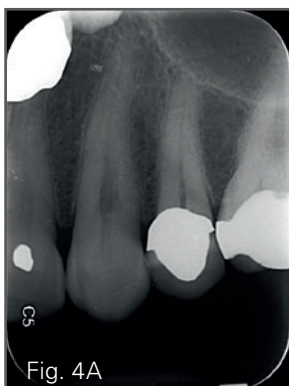
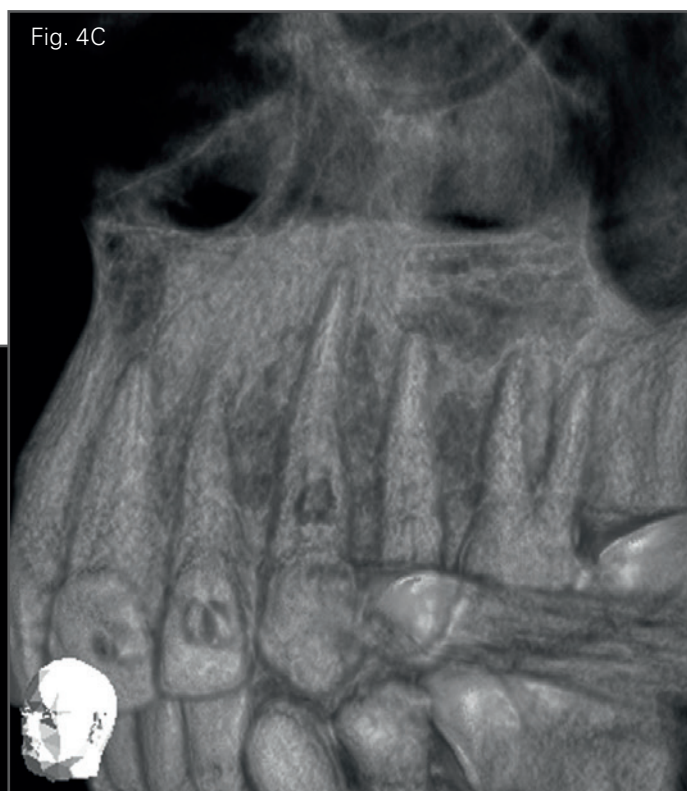
The patient presented with pain to palpation over tooth # 11. Vitality testing revealed that the tooth was vital. The conventional preoperative radiograph showed an unusual appearance of the root canal space just apical to the CEJ (Fig. 4A).

All periradicular bone appeared to be normal. Accuitomo imaging revealed (Figs. 4B & C) a large internal/external resorption defect on the buccal surface of the root just above the osseous crest of bone, dictating extraction. Typically, treatment of this tooth would have been instituted, wasting the patient's time and money when the tooth was hopeless.

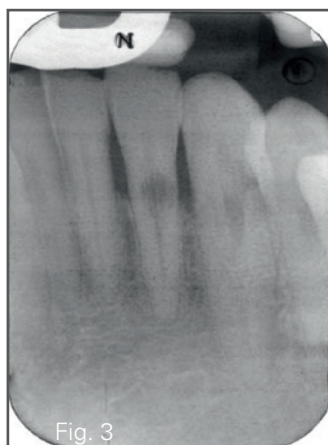
Fig. 3 shows the periapical radiograph of a 54 year old asymptomatic male patient. Panoramic and periapical radiographs were taken during a routine dental examination, reveal enlargement of the pulpal cavity of teeth # 22 and 23, consistent with internal resorption. However, these radiographs do not offer any information regarding the extent of the resorption and thus do not aid in the treatment planning (i.e. endodontic treatment vs. extraction) of the patient. Clinical examination was unremarkable. An Accuitomo scan delineated the extent of internal root resorption in both teeth. Interestingly, in addition to the internal resorption, external resorption at the cervical area of both # 22 and # 23 was observed. Based on the extent of the internal and presence of external root resorption the teeth were deemed unrestorable.
